NASA WG3 MMOD Protection Summary

Interagency Space Debris Coordination Committee (IADC)

May 2012

IT 29-1: Hypervelocity Facility CNSA-NASA Cross-Calibration

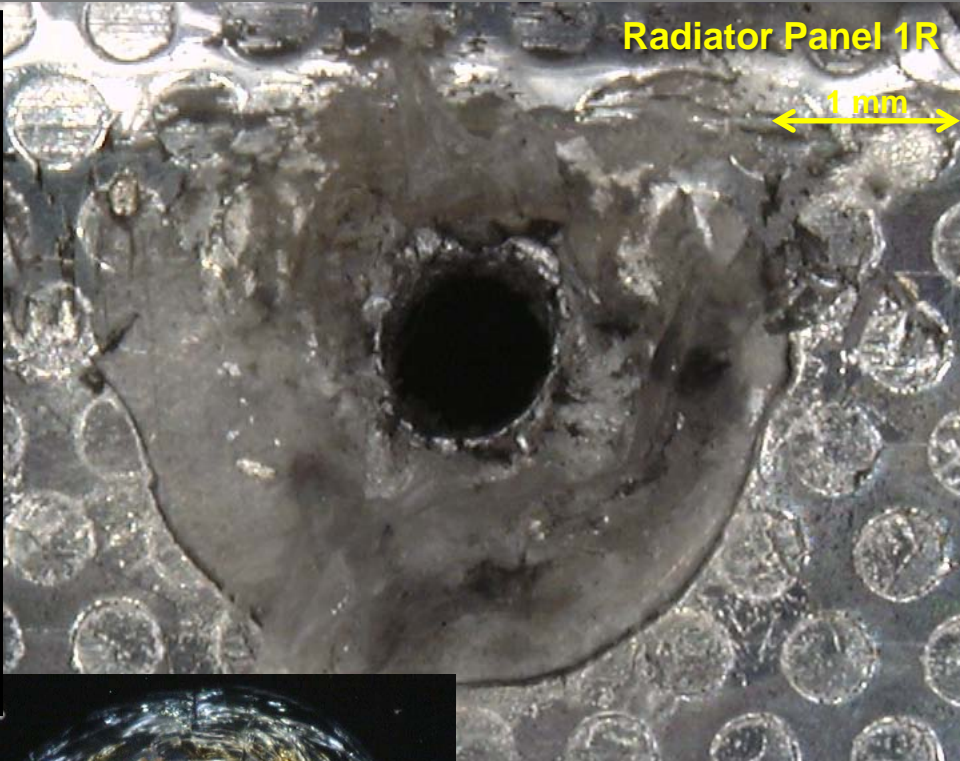
Radiator Panel 1R

Number of MMOD Impacts	Largest MMOD Impacts
Windows	7 craters	W6: 2.5 x 2.5 mm damage extent
Radiators	3 MMOD damages reported	1 face sheet perforation
RCC	9 MMOD indications	Panel 9L: 2.3 x 1.9mm, depth = 0.4 mm exposed substrate

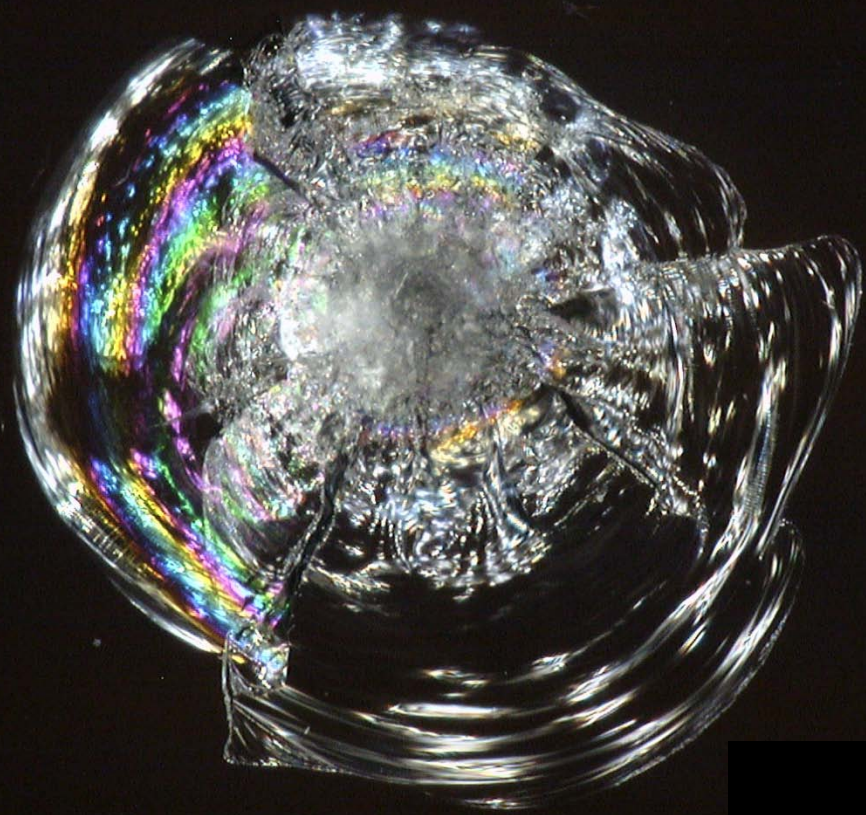
Window 3

Number of MMOD Impacts	Largest MMOD Impacts
Windows	10 craters	W3: 3.7 x 3.5 mm damage extent
RCC	13 MMOD indications	Panel 9L: 1.3 x 1.0mm, depth = 0.27 mm no exposed substrate

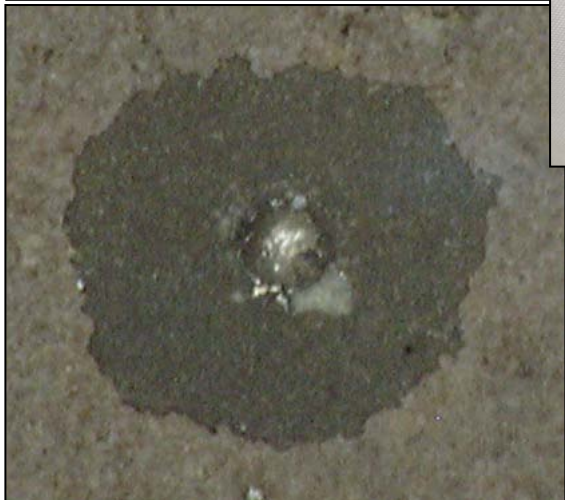
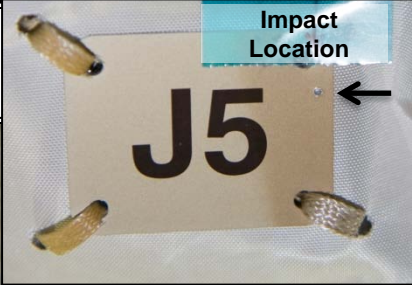
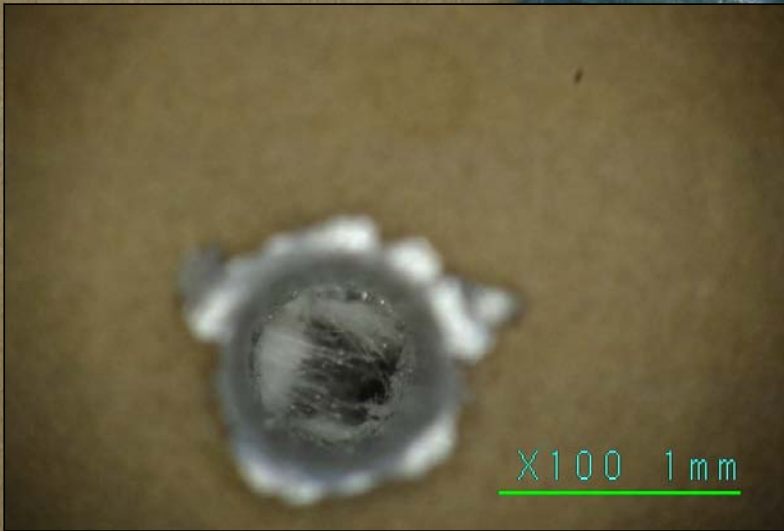
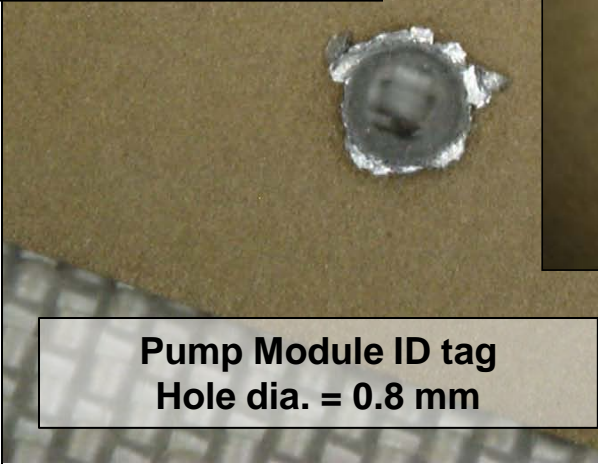
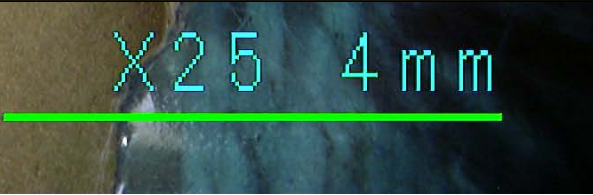
Inspected after STS-135	MMOD Exposure	Number of MMOD Impacts	Largest MMOD Impacts
Multi-Purpose Logistics Module (MPLM)	7.0 days on ISS, 5.7 days in payload bay	64 craters between 0.1mm and 0.7mm diameter	0.7mm dia. crater in 0.8mm thick Al bumper
Pump Module Integrated Assembly (PMIA)	8.7 years on ISS	PM: 36 impact features LAPA: 19 impact features	PM: 0.8mm dia. perforation in Al tag LAPA: 1.8 x 1.8mm crater in Al handrail

MPLM grapple fixture
coating spall dia. = 0.6 mm

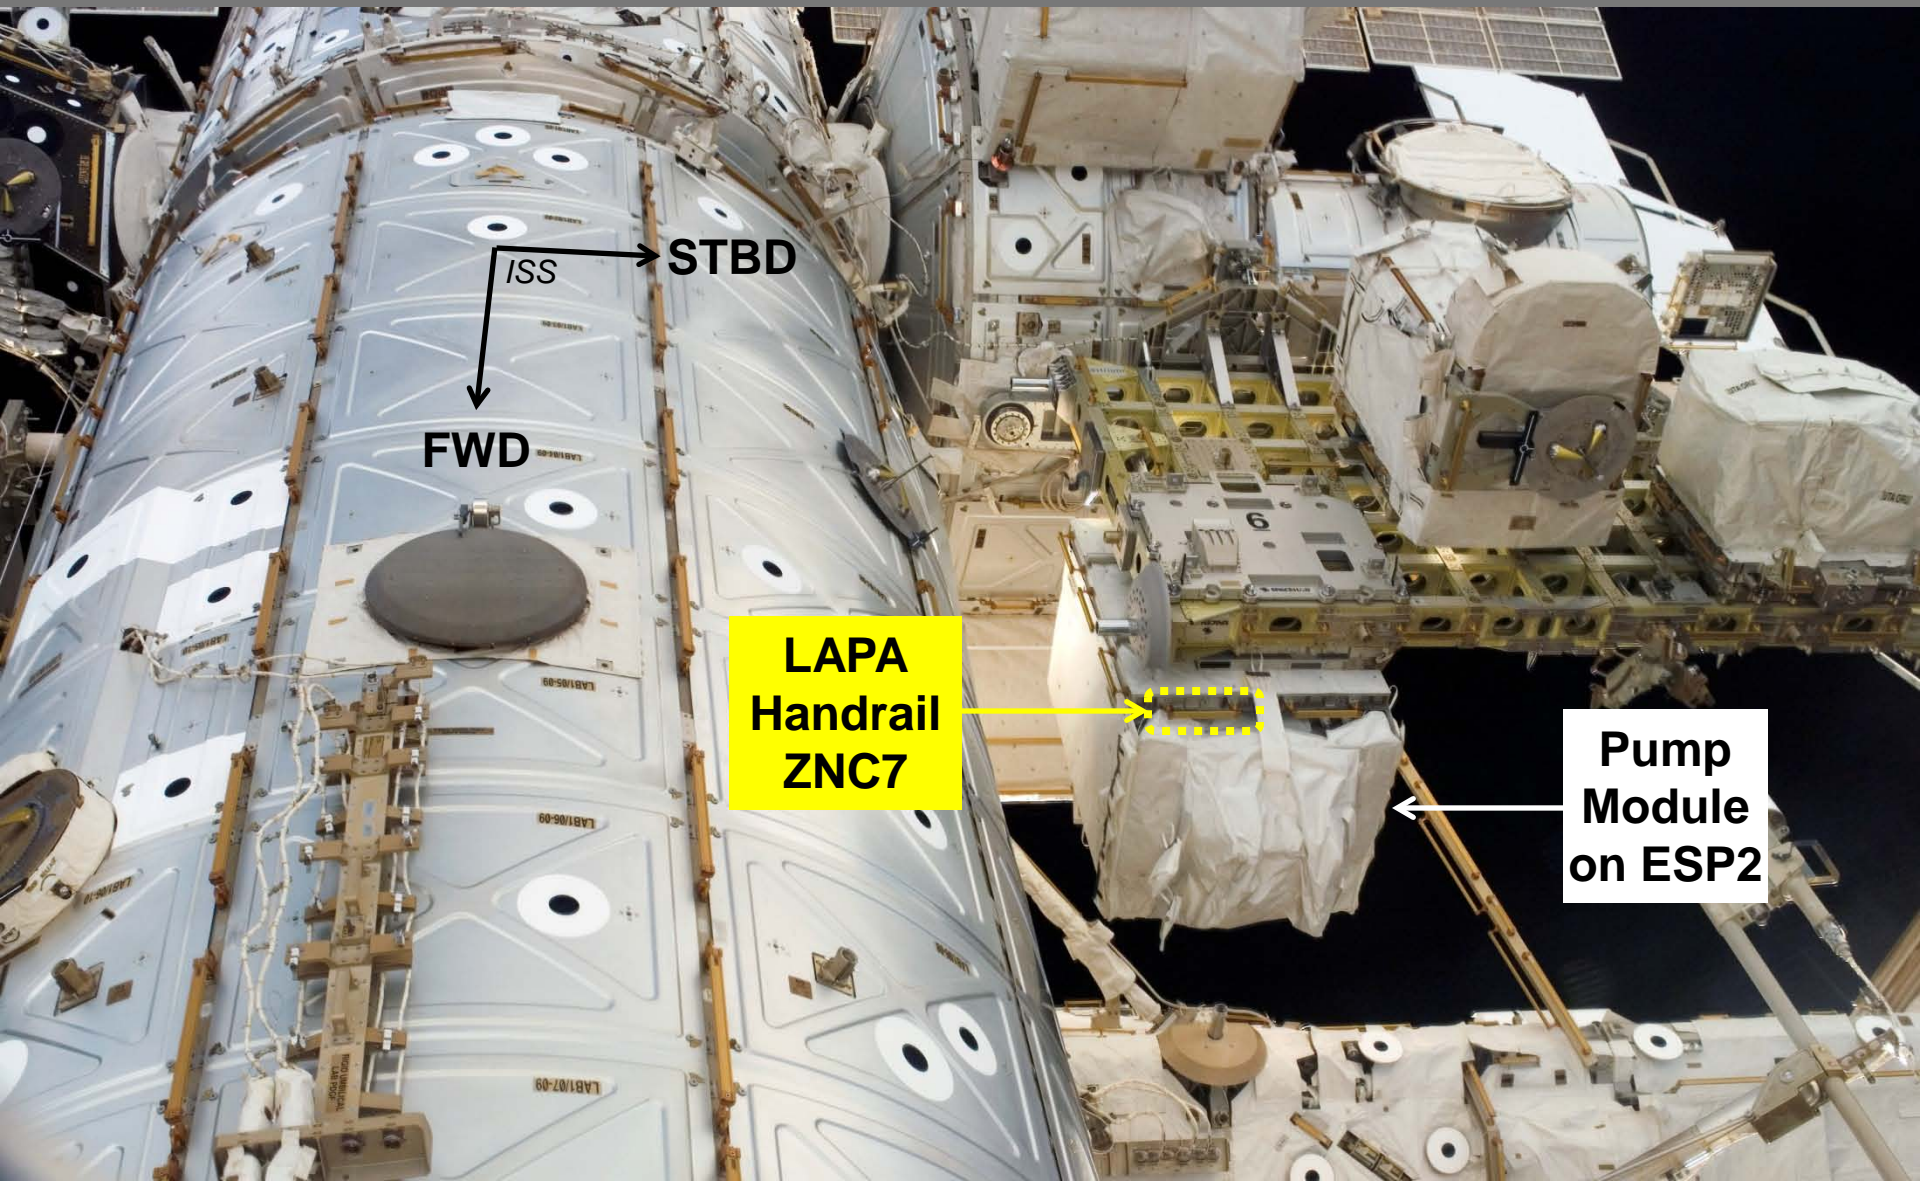
LAPA
Handrail
ZNC7

**1.8 mm diameter
crater in handrail ZNC7**

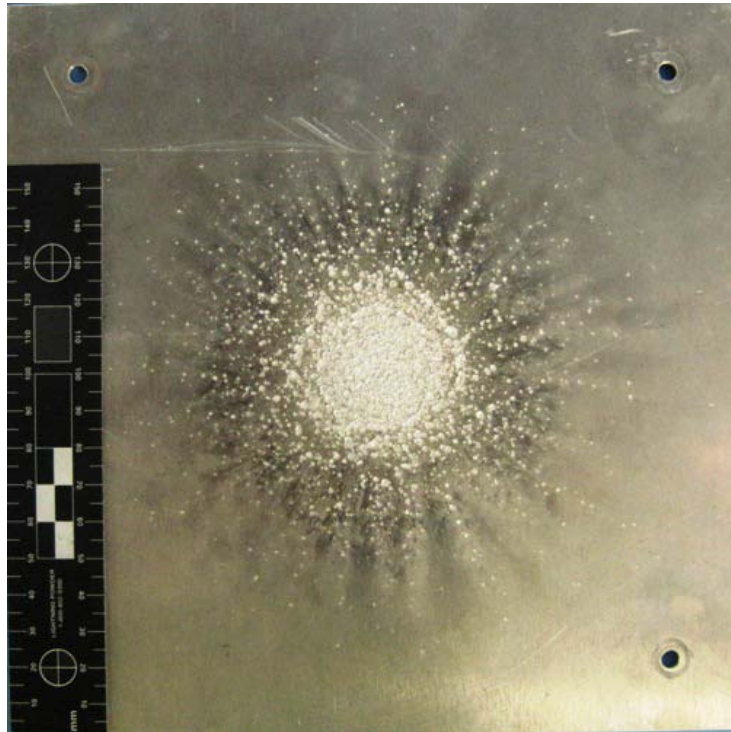
Front

- HITF-11146, 3.2mm AL 2027 projectile, 0.04779g, 5.77km/s, 0deg
 - **2nd layer front side:** multiple craters (no through-holes), maximum crater size 1.6 mm diameter x 1.7 mm deep, circular area of concentrated crater damage within 44 mm diameter, majority of crater damage (>95% of craters) are within 130 mm diameter

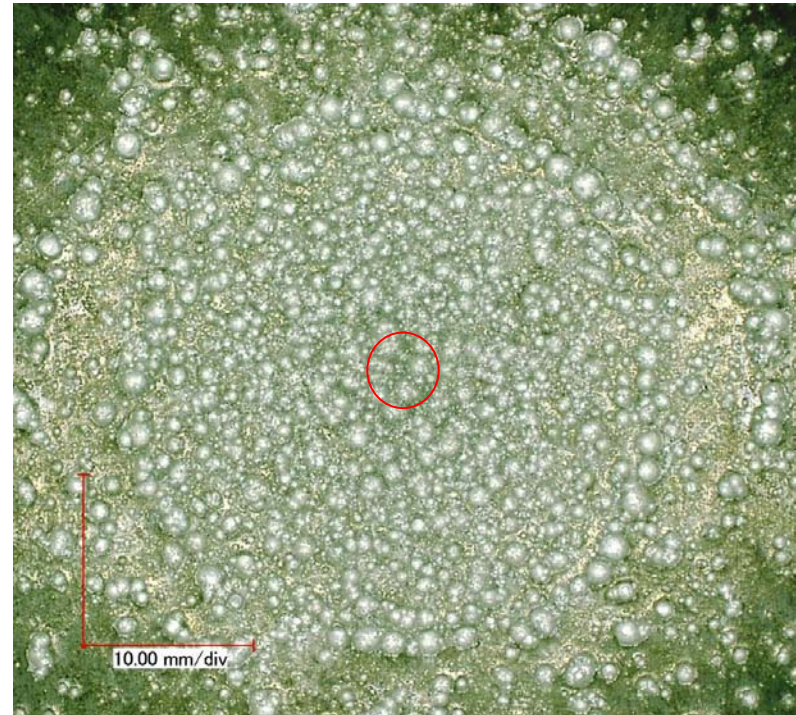
Front, close-up

Deepest penetration within red circle

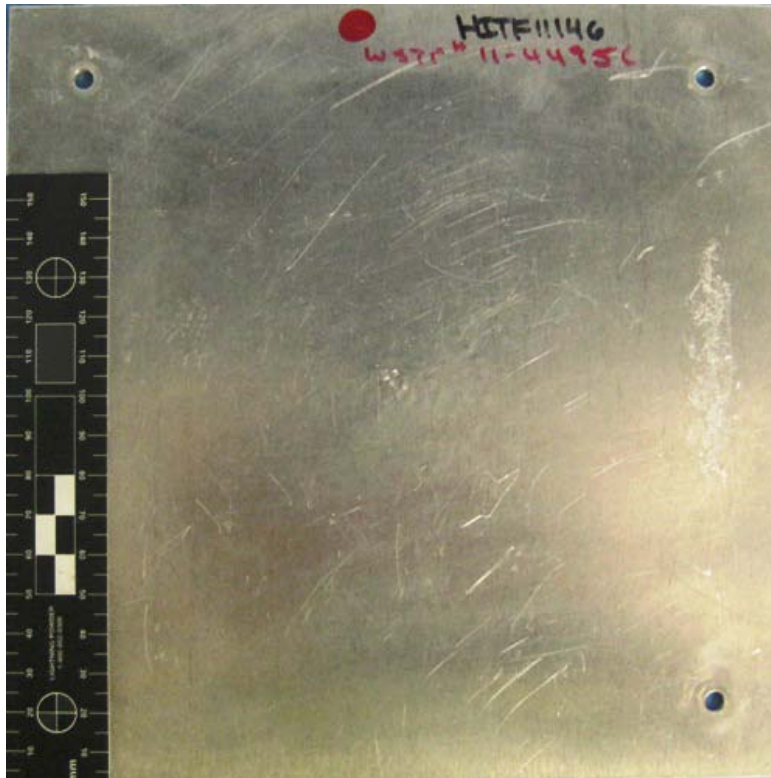
Back

- HITF-11146, 3.2mm AL 2027 projectile, 0.04779g, 5.77km/s, 0deg
 - **2nd layer back side:** small bumps on back side of plate within 64mm x 66mm area, maximum height 0.8mm, no detached spall present

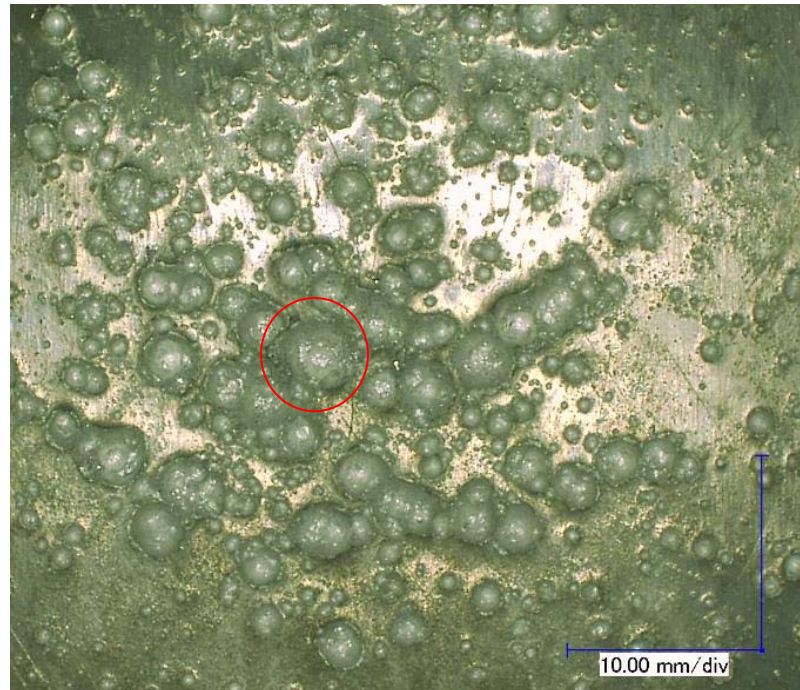
Front, close-up

- HITF-11147, 3.2mm AL 2027 projectile, 0.04788g, 5.30km/s, 30deg
 - **2nd layer front side:** multiple craters (no through-holes), maximum crater size 3.5 x 3.2 mm diameter and 1.8 mm deep, concentrated area of crater damage within 44 x 36 mm diameter

Deepest penetration within red circle

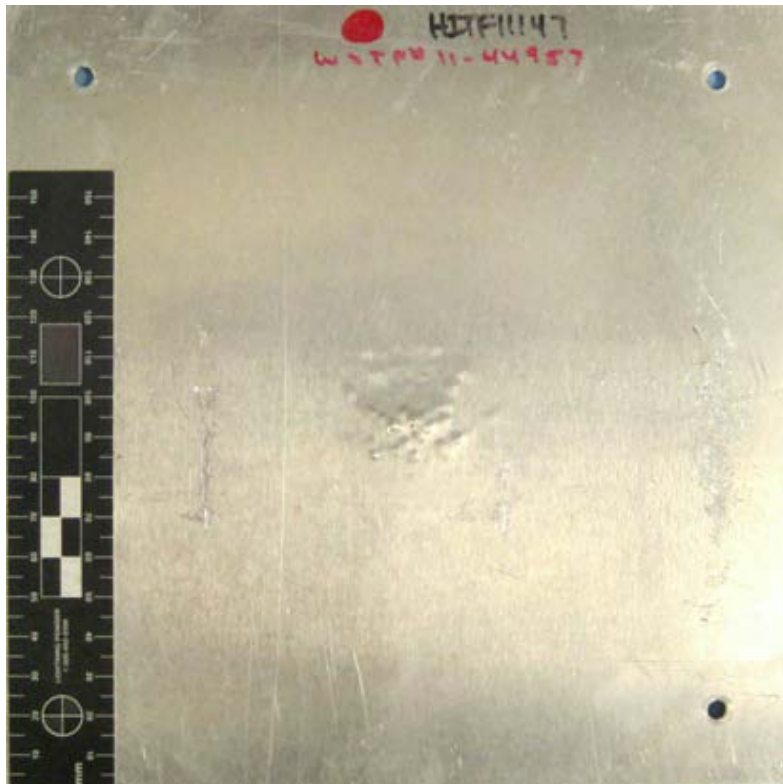
Back

- HITF-11147, 3.2mm AL 2027 projectile, 0.04788g, 5.30km/s, 30deg
 - **2nd layer back side:** small bumps on back side of plate within 65mm x 63mm area, maximum height 0.8 mm, no detached spall present

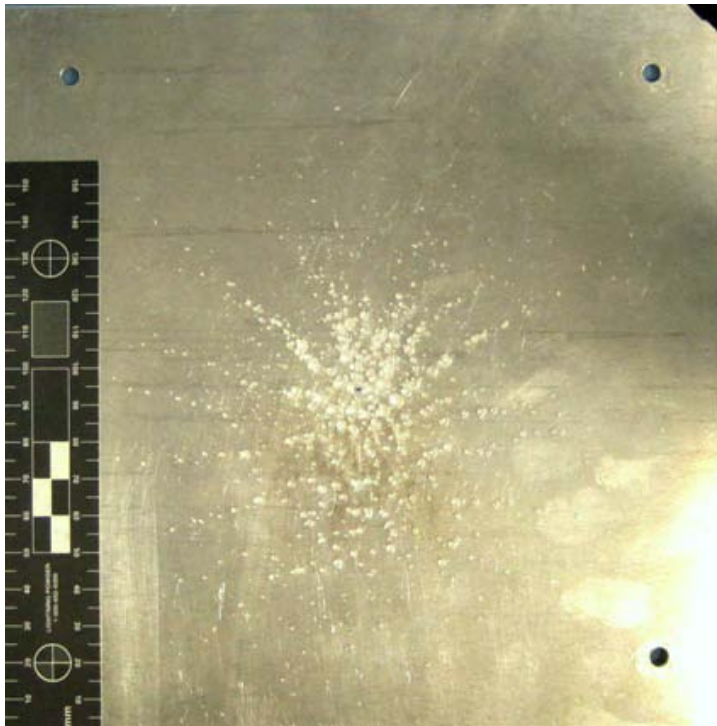
Front

- HITF-12092, 3.2mm AL 2027 projectile, 0.04767g, 5.01km/s, 30deg
 - **2nd layer front side:** One through hole (rear wall failed), multiple craters, hole size 1.4 x 0.8 mm, maximum crater size 3.4 x 2.6 mm diameter, concentrated area of crater damage within 41 x 39 mm diameter

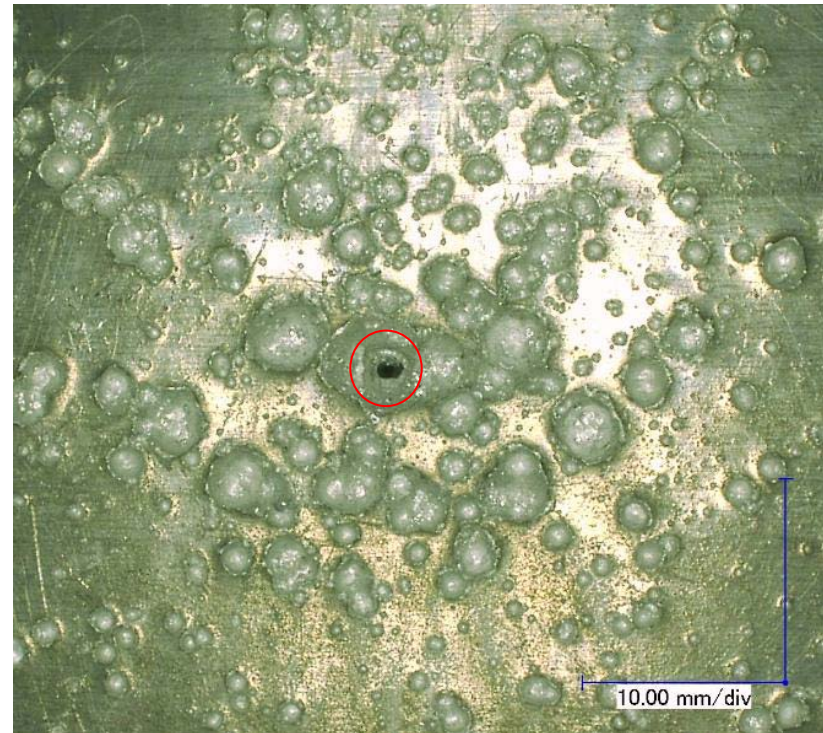
Front, close-up

Complete penetration within red circle

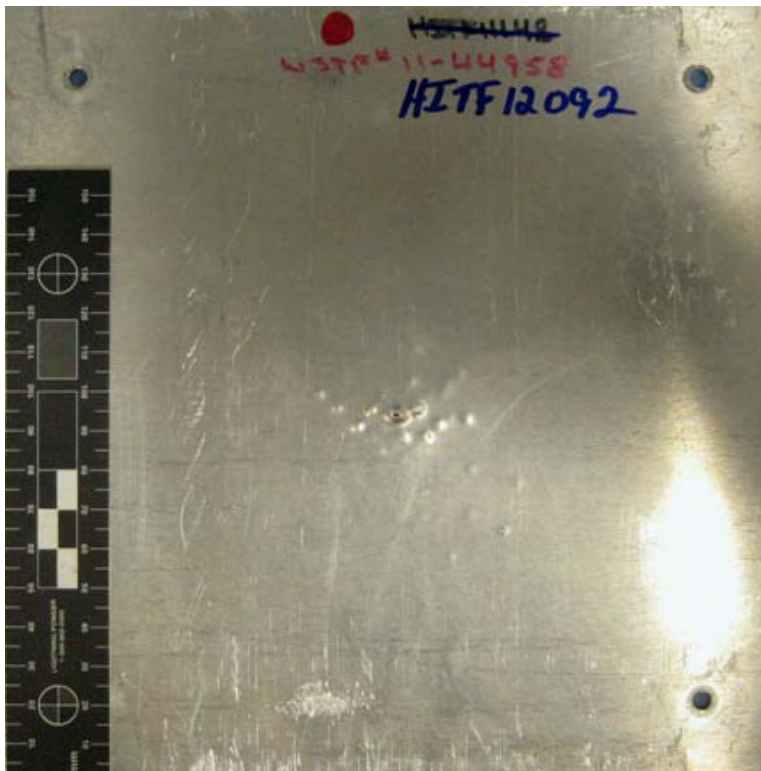
Back

- HITF-12092, 3.2mm AL 2027 projectile, 0.04767g, 5.01km/s, 30deg
 - **2nd layer back side:** small bumps on back side of plate within 63mm x 61 mm area, maximum height of bump at perforation 2.1 mm above surface

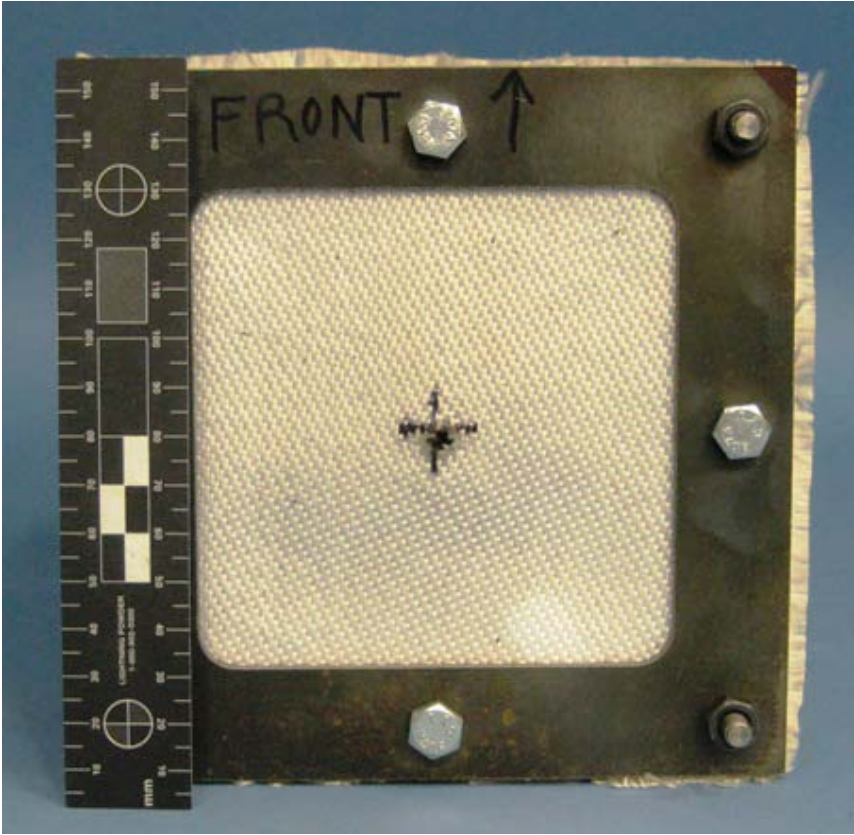
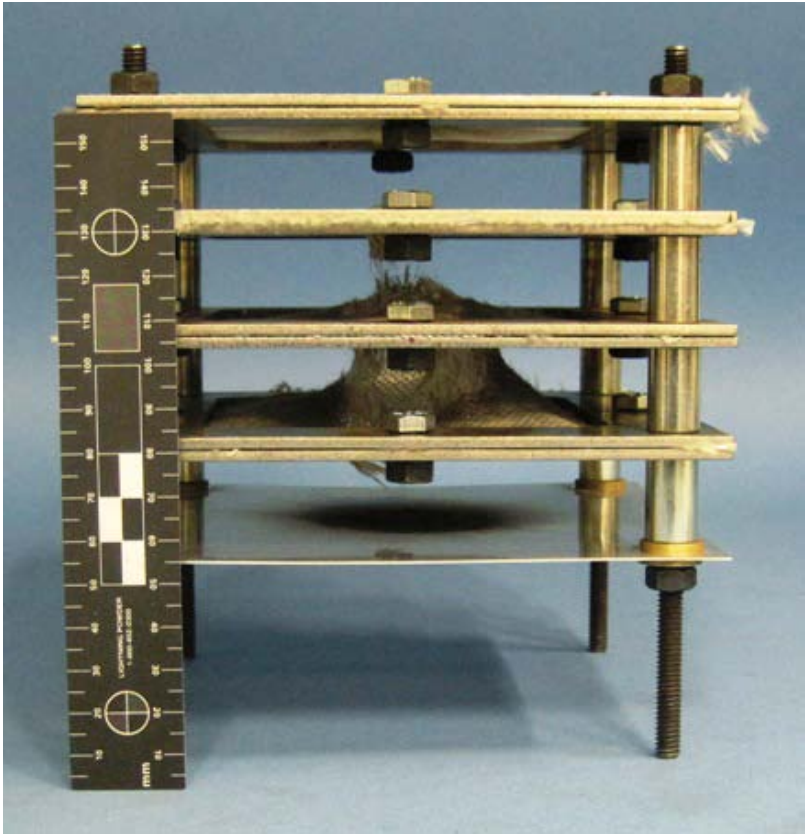
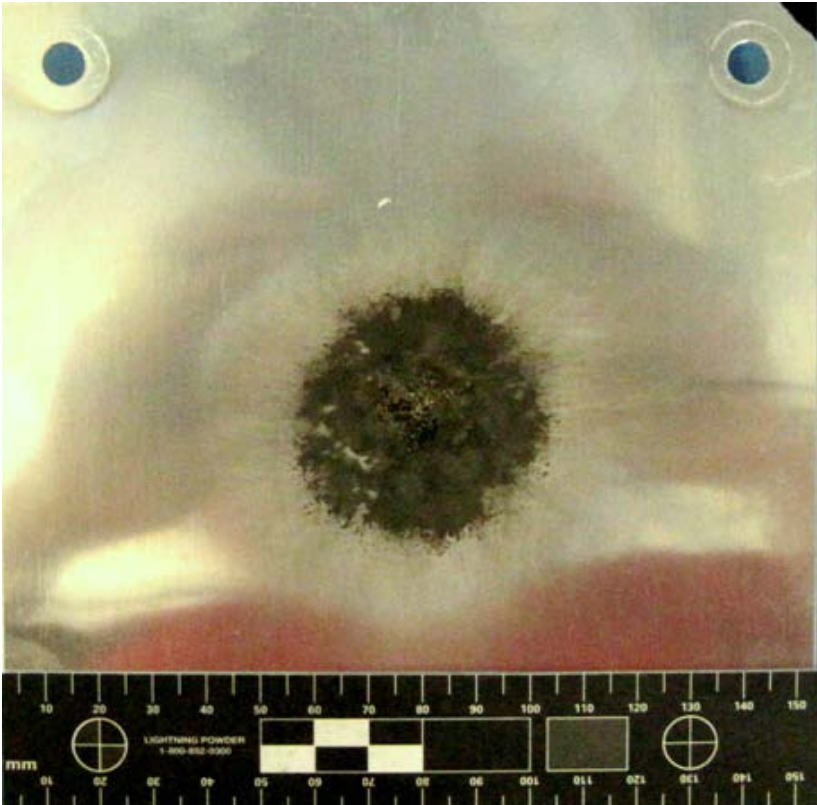
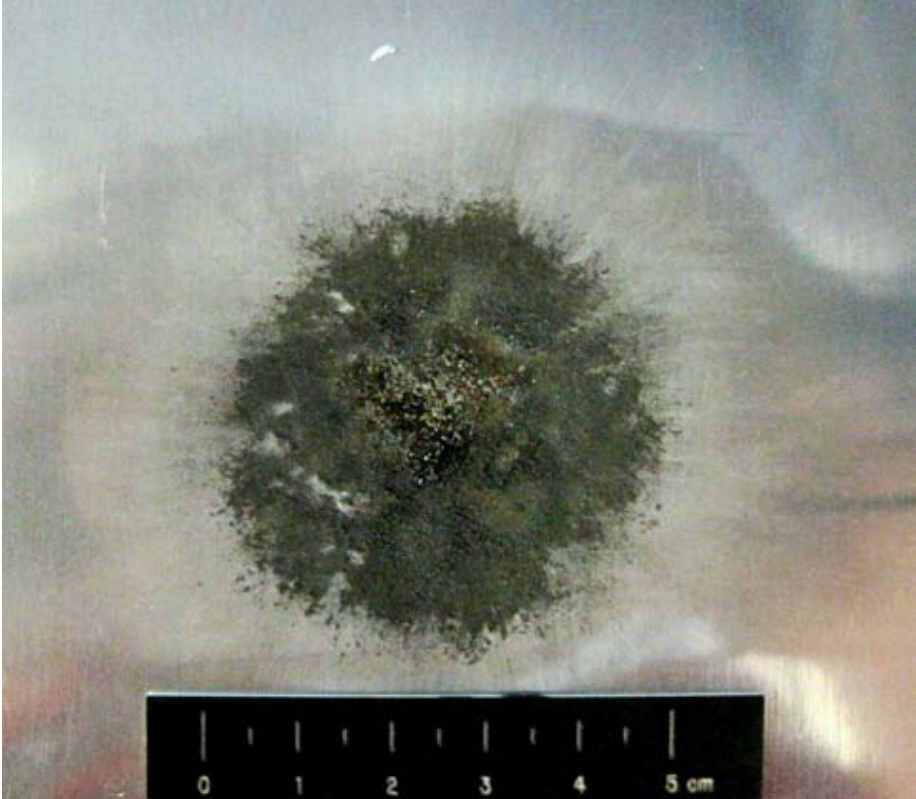
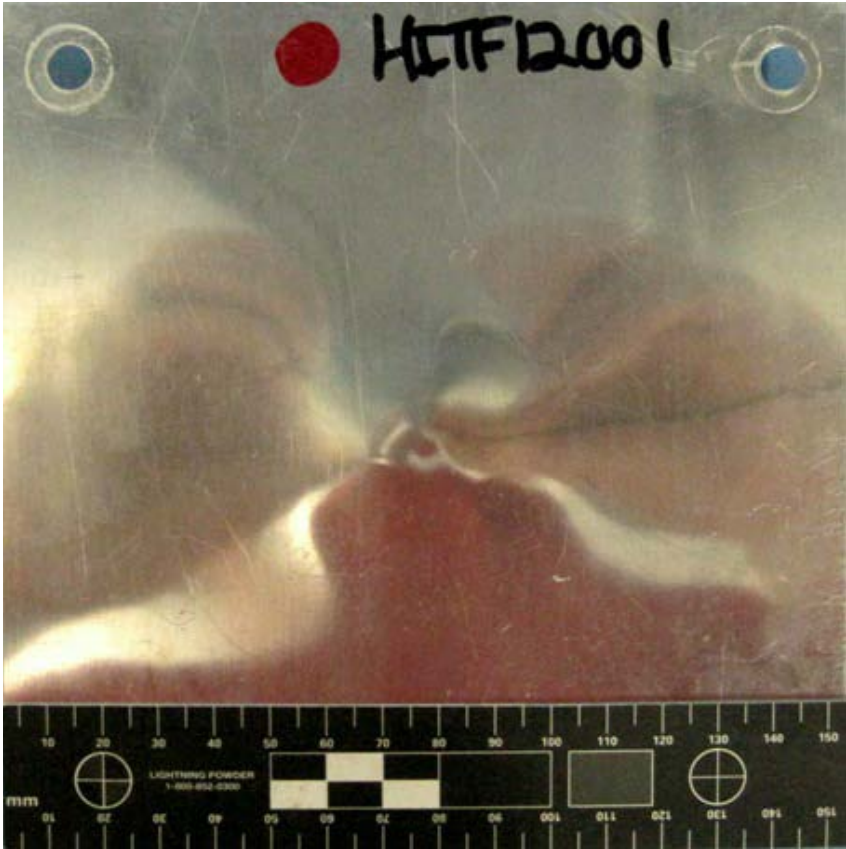
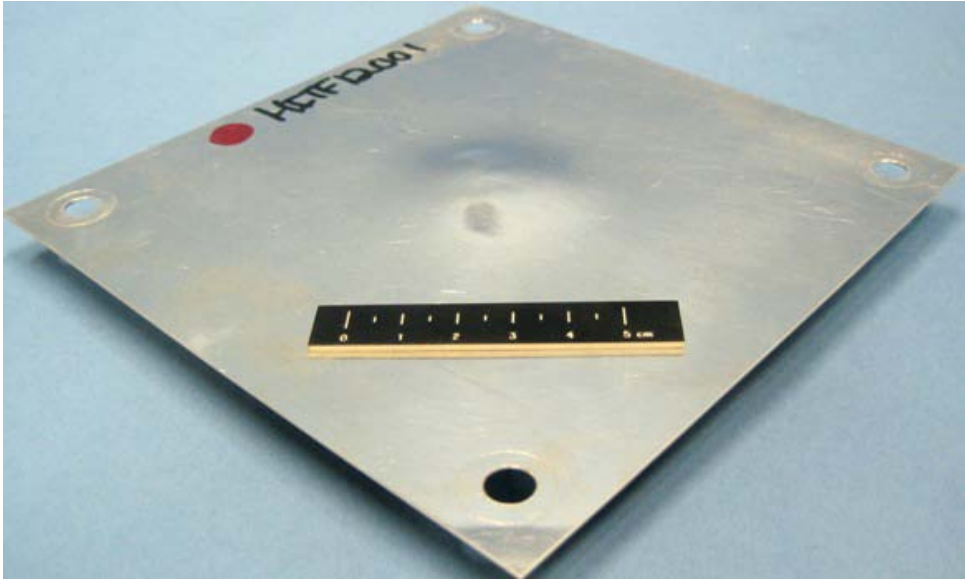
HITF-12001, Multishock 0.36g/cm²
3.2mm diameter Al 2017T4, 6.93 km/s, 0deg

Test number	Projectile impact conditions	Target Configuration and overall mass per unit area	Damage to bumper layers	Damage to aluminum rear wall
#1. HITF-12001	3.2mm Al, 0.04725g, 6.93 km/s, 0 deg impact angle	Multishock shield 0.36 g/cm ²	1 st layer: 5.5 x 4.6 mm hole 2 nd layer: 17.0 x 16.7mm hole 3 rd layer: 42.9 x 27.5mm hole 4 th layer: 45.1 x 33.3mm hole	Bulge, dish (no failure) Impacted area 48mm diameter, bulge is 60mm diameter by 3.5mm high

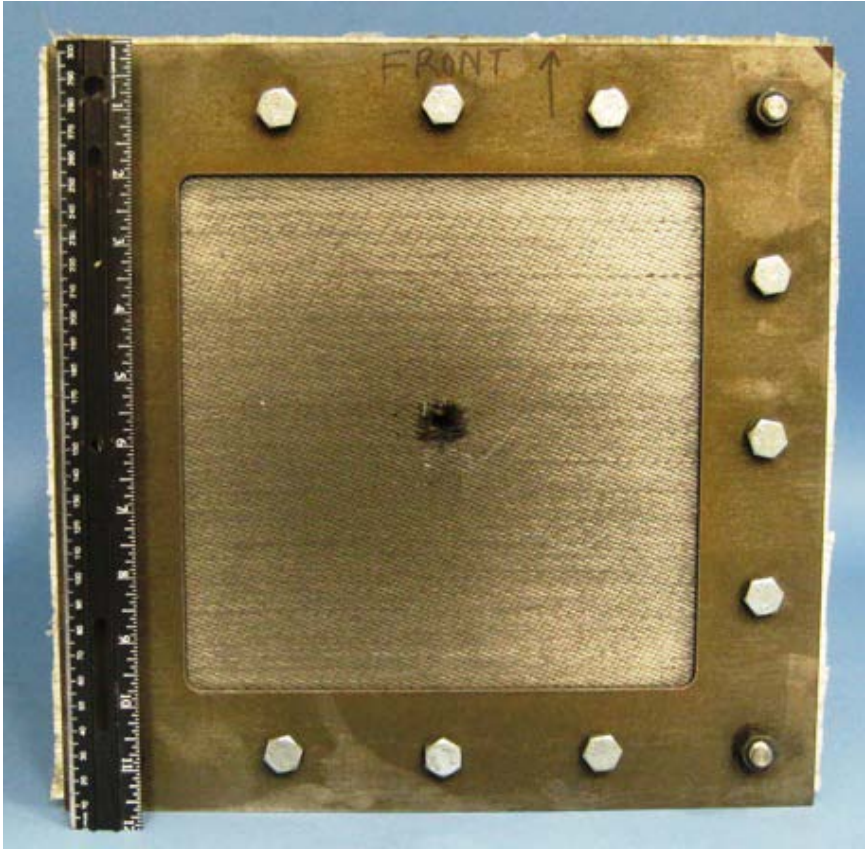
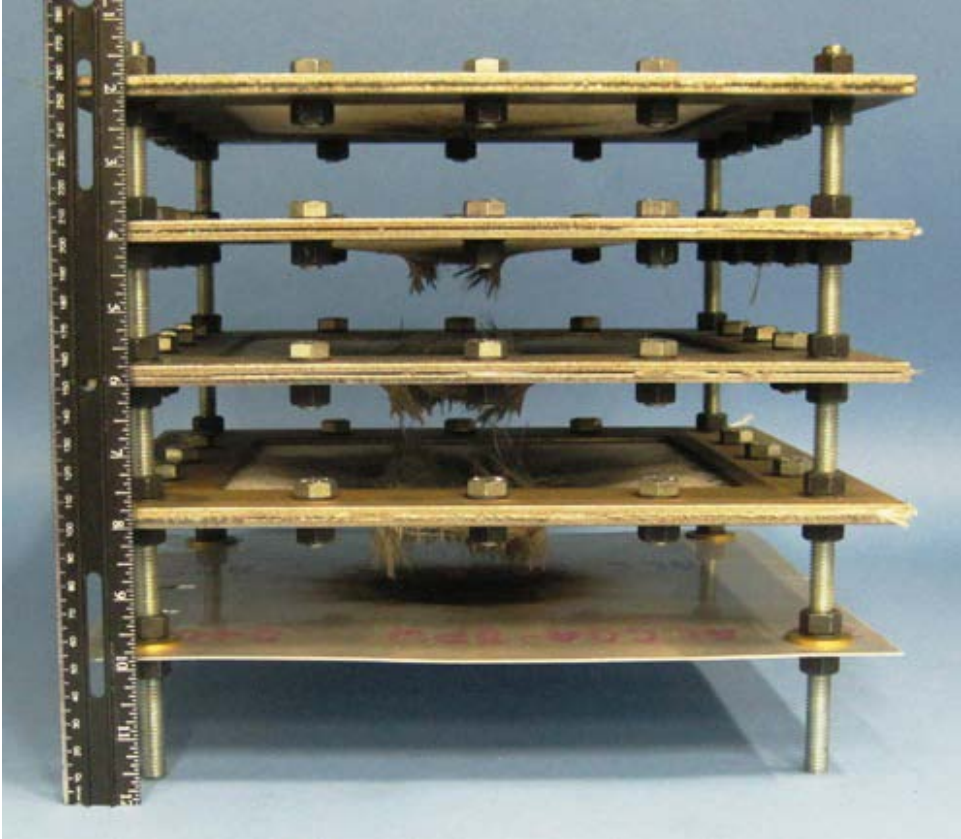
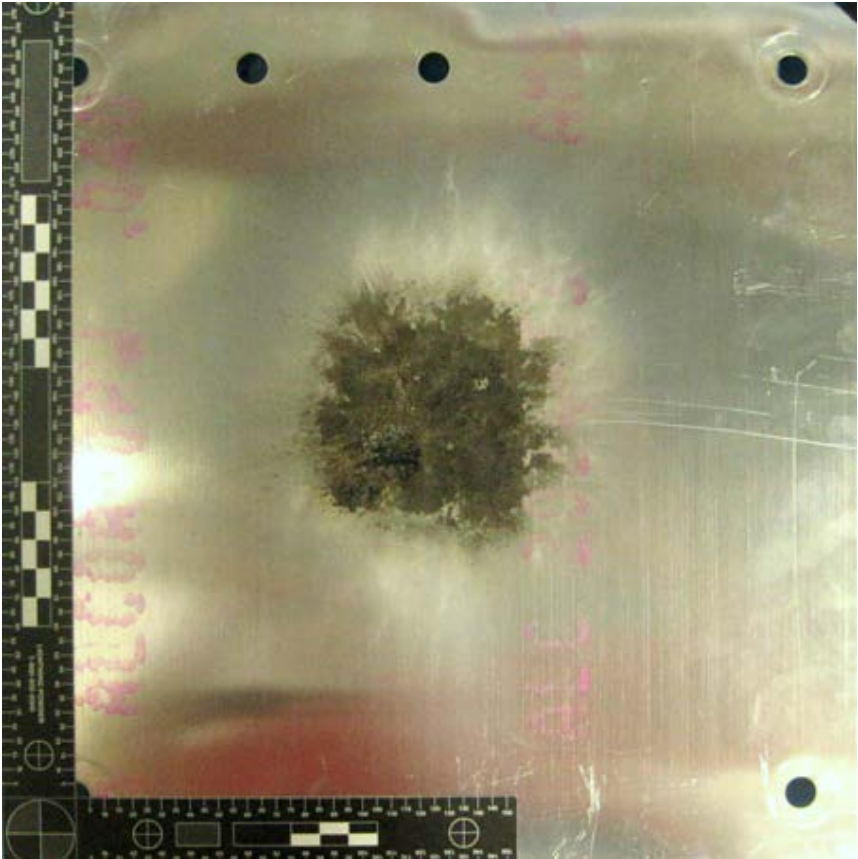
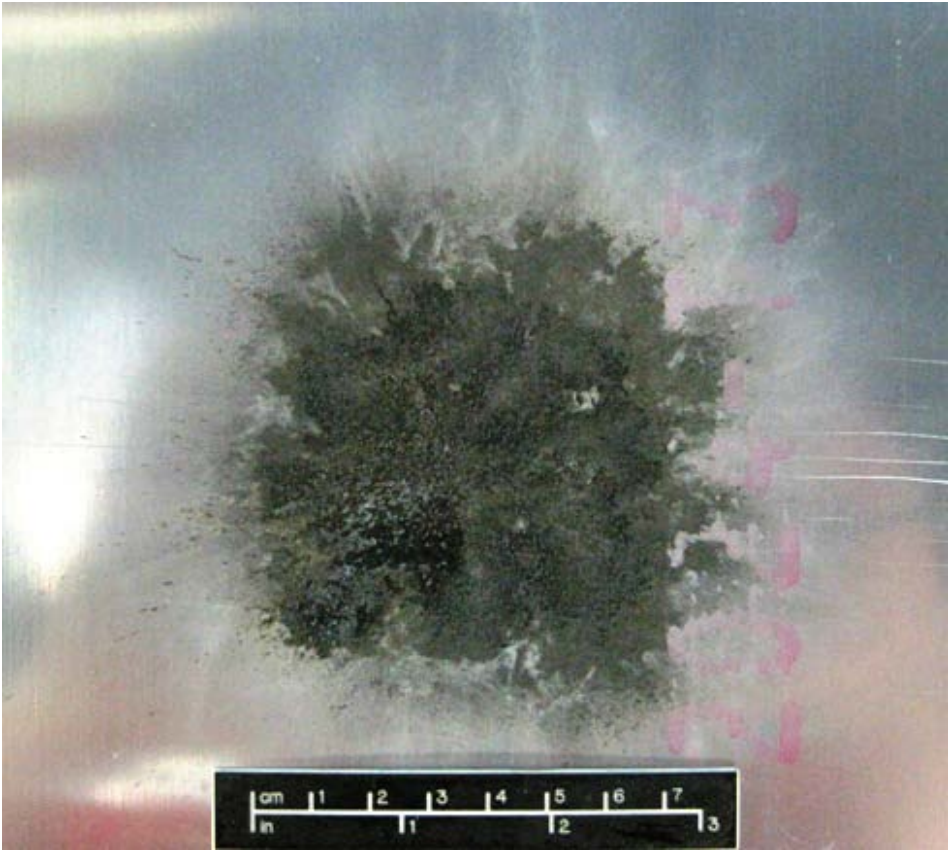
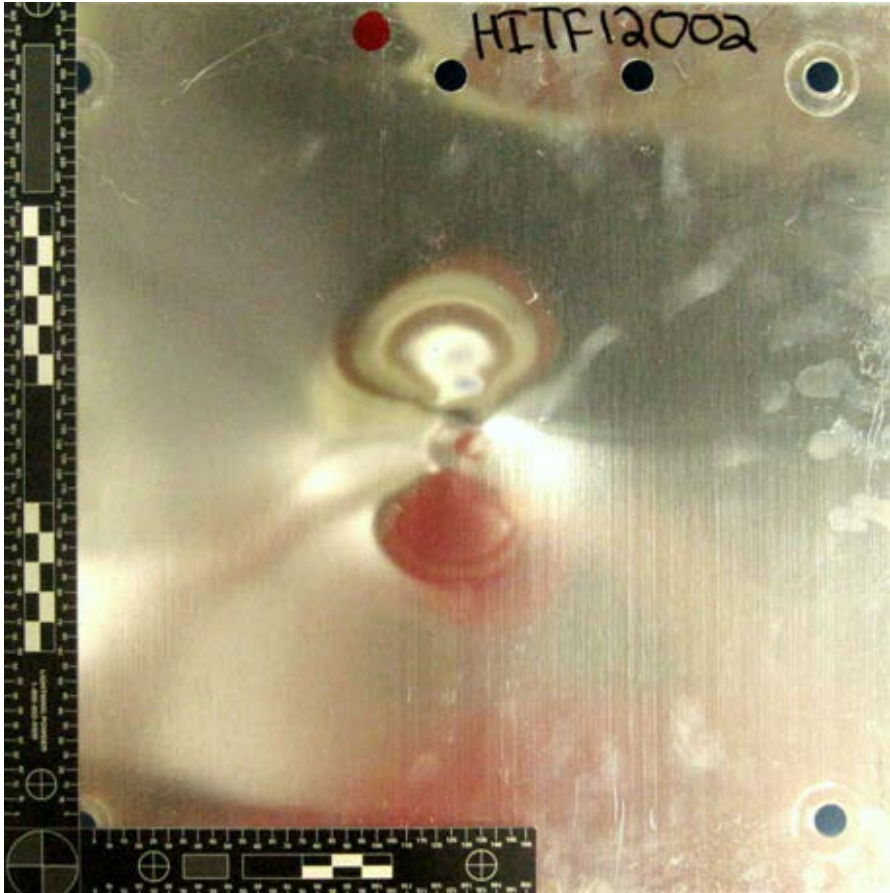
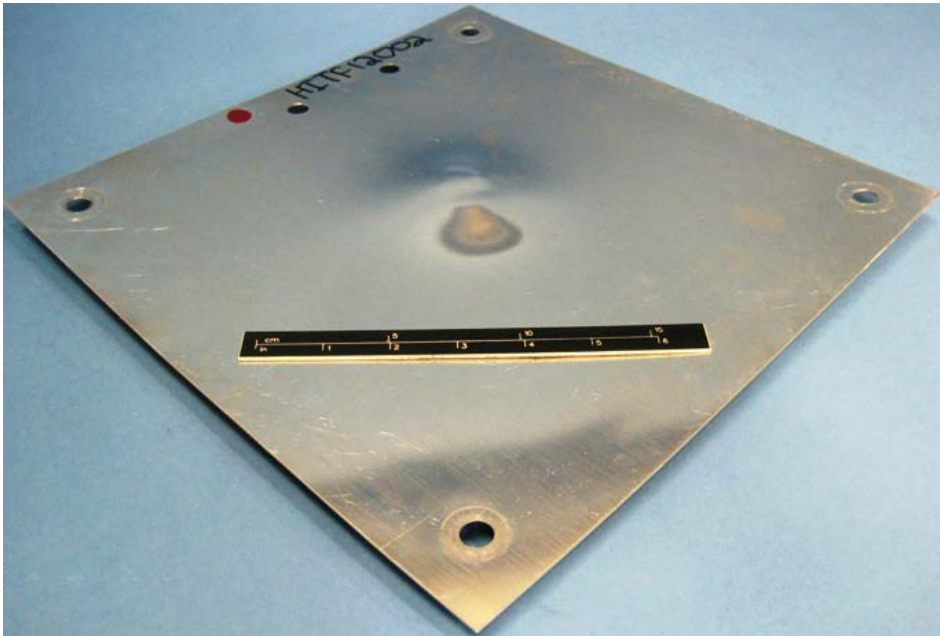
HITF-12002, Multishock 0.647g/cm²
6.4mm diameter Al 2017T4, 6.86 km/s, 0deg

#2. HITF-12002	6.4mm Al, 0.37406g, 6.86 km/s, 0 deg impact angle	Multishock shield 0.65 g/cm ²	1 st layer: 10.0 x 9.8mm hole 2 nd layer: 30.1 x 27.3mm hole 3 rd layer: 46.7 x 44.3mm hole 4 th layer: 65.6 x 50.5mm hole	Bulge, dish (no failure) Impacted area 86mm diameter, bulge is 116mm diameter by 9.4mm high

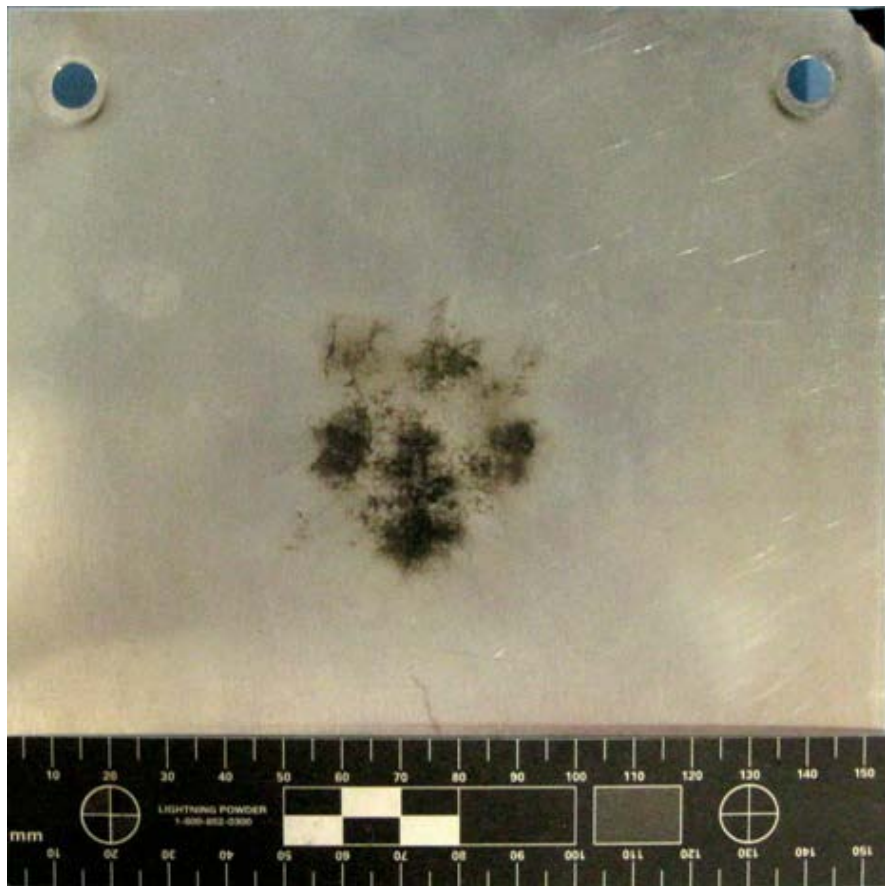
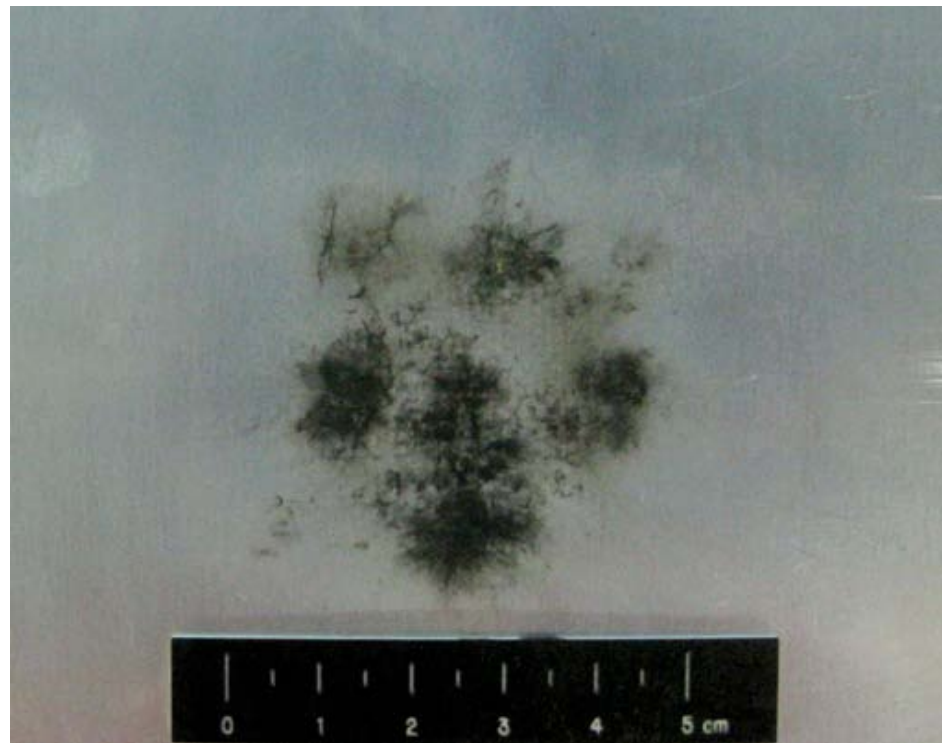
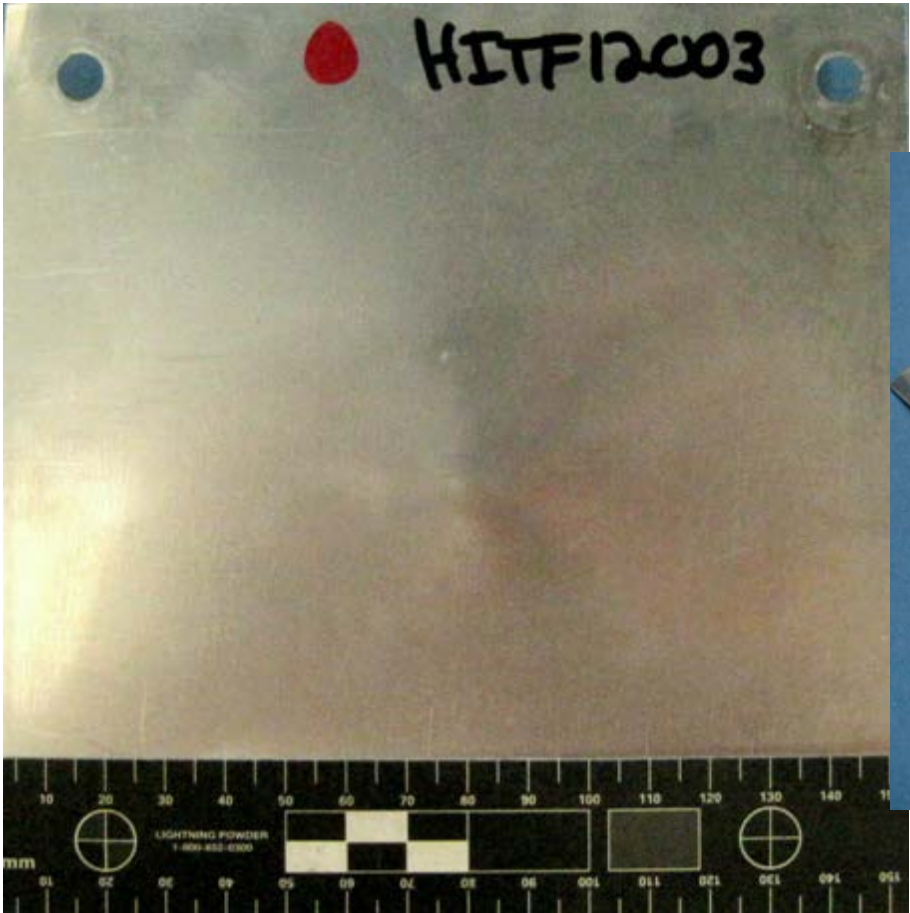
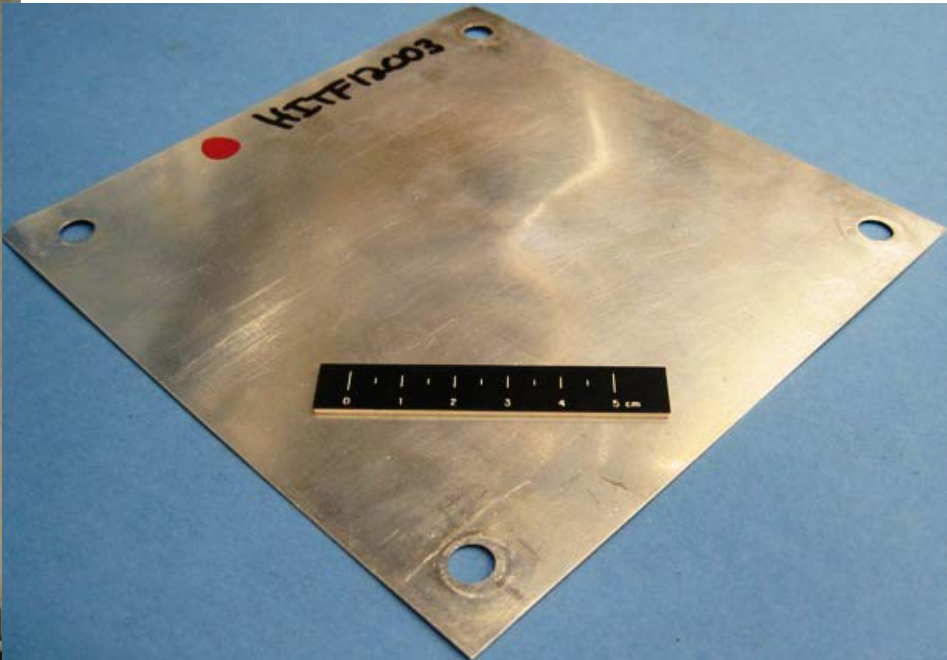
HITF-12003, Mesh Double Bumper 0.33g/cm² 3.2mm diameter Al 2017T4, 6.85 km/s, 0deg

#3. HITF-12003	3.2mm Al, 0.04725g, 6.85 km/s, 0 deg impact angle	Mesh Double Bumper shield 0.33 g/cm ²	1 st layer: 6.3 x 5.9mm hole 2 nd layer: 8.9 x 8.7mm hole 3 rd layer (last layer of Kevlar): multiple perforations in 54 x 42 mm area, with largest hole 3.9 x 3.8mm	Bulge, dish (no failure) Impacted area 48 x 42mm diameter, bulge is 43 x 37mm diameter by 1.3mm high
